4. TITLE (and Subtitle) Foundation Report Cold Brook Dam, Hot Springs, South Dakota Fall River Basin		5. TYPE OF REPORT & PERIOD COVERED Final Report
7. AUTHOR(s) U.S. Army Engineer District, Omaha		6. PERFORMING ORG. REPORT NUMBER

FOUNDATION REPORT
COLD BROOK DAM

Hot Springs, South Dakota
January 1954

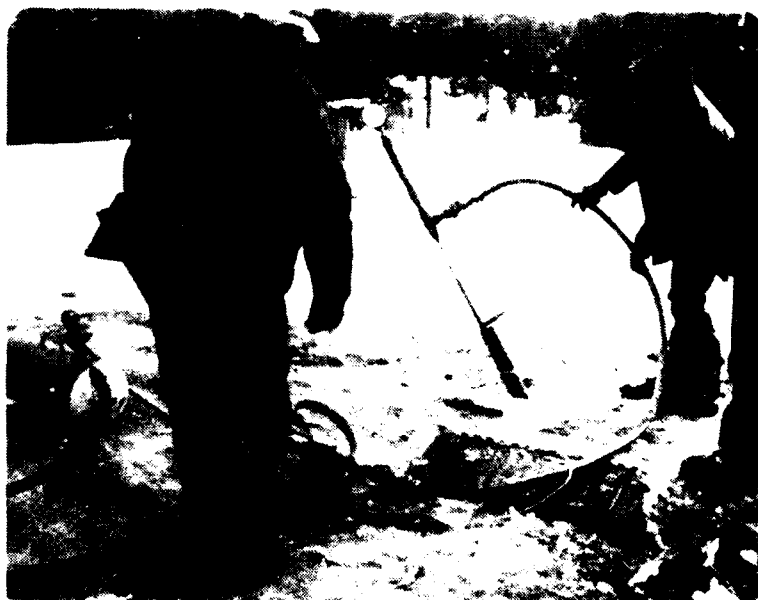
PHOTO NO. A-7: Water pressure test showing header, pressure gauge, packer inflation line and water meter.
